Face milling of nickel-based superalloys with coated and uncoated carbide tools

**FACE MILLING OF NICKEL-BASED SUPERALLOYS WITH
COATED AND UNCOATED CARBIDE TOOLS**

**A thesis submitted in partial fulfilment of the University's requirements
for the award of the Degree of Doctor of Philosophy**

SYNOPSIS

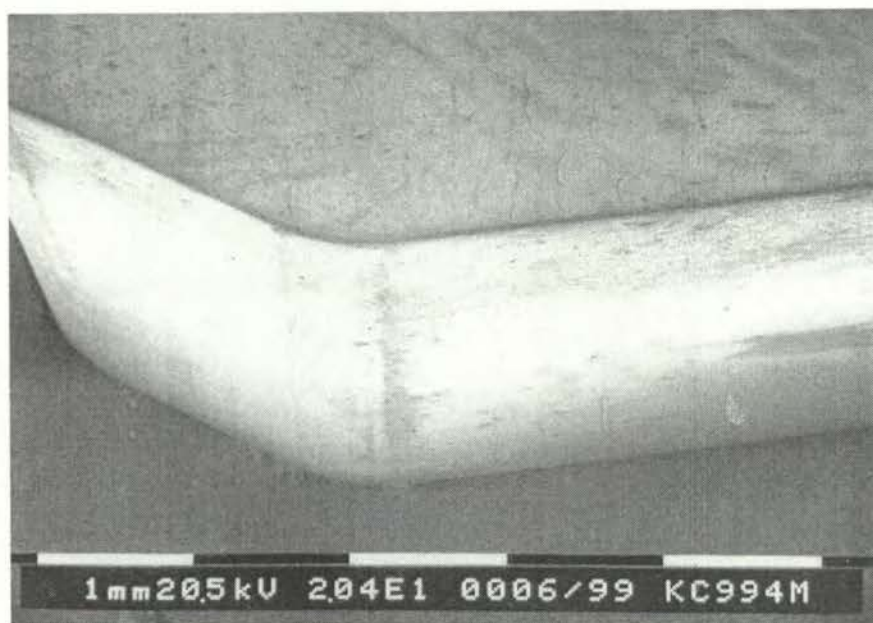
Figure 6.10 Sharp cutting edge of the PVD-TiN coated KC720 and KC730 insert

Two different PVD-TiN coated carbide inserts, KC720 and KC730 (Figure 6.10) grades, a CVD-TiCN+Al₂O₃ (Figure 6.11) double-layer coated insert of KC994M grade and an uncoated carbide insert of KMF (Figure 6.12) grade were used in this study. Microstructures of all the tools are shown in Figures 6.13 to 6.16 respectively. All the cutting tools possess the same standard geometry with ISO designations SEKN1204AFN and SEKN1203AFN for the coated and uncoated inserts respectively. They were manufactured and supplied by Kennametal-Hertel UK. In the case of CVD coated inserts, the cutting edge was honed to a radius of ~ 0.025 mm prior to coating process. All the inserts were checked, prior to machining, for any physical deficiency by means of a microscope at a magnification of x8. Figure 6.17 shows the geometric properties of the inserts. Some of the important physical and mechanical properties of inserts are given in Tables 6.5 and 6.6.

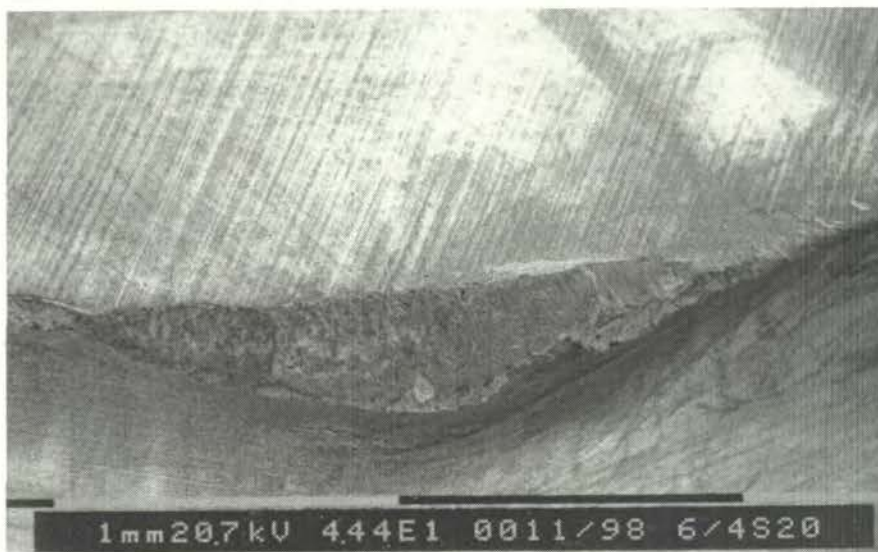
Figure 7.2 Premature catastrophic failure with severe flaking of KC994M tool after 1 minute machining of Inconel 718 at 75 m/min and 0.14 mm/tooth

Tools were rejected due to average nose wear at all cutting speeds and feed rates tested. The dominant wear modes at tool failure were chipping and material adhesion in the form of galling and/or sticking of relatively large particles. Figures 7.2, 7.3 and 7.4 show failed KC994M tools with wear modes of galling, chipping and flaking under various cutting conditions. Premature failure of the cutting edge, usually within 1 minute of cutting time, due to severe chipping, breakage and/or flaking was observed at higher cutting speeds of 75 and 100 m/min for both high and low feed rate conditions (Figure 7.2 and 7.3). However, at the lowest cutting speed of 25 m/min, a combination of progressive wear by plucking, pitting, microchipping and workpiece galling were the dominant causes of tool failure, as shown in Figure 7.4.

At higher cutting speeds premature chipping or breakage was found to be the life limiting factor for all the tools investigated as shown in Figures 7.2, 7.17, 7.30, 7.40, 7.90, 7.92, 7.106, 7.121 and 7.133.

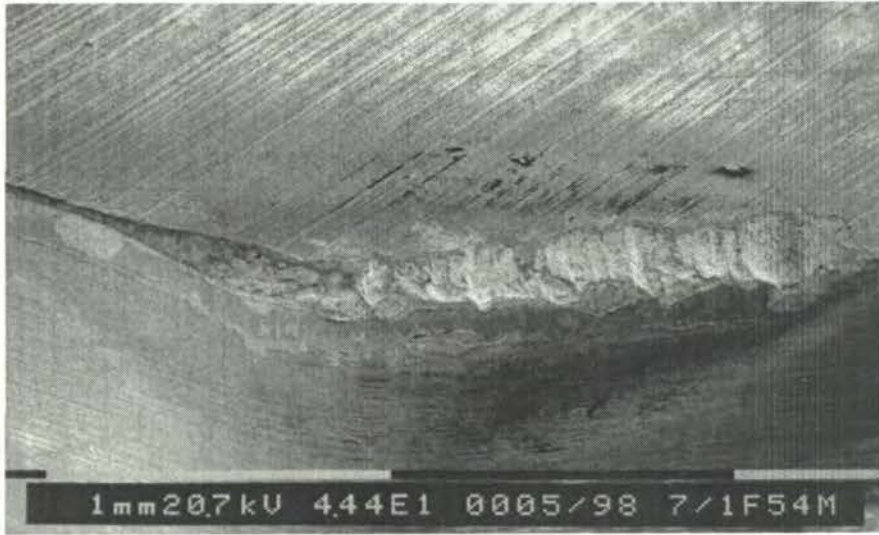
Figure 7.3 Severe breakage at the cutting edge of KC994M tool failed prematurely after 20 seconds when face milling Inconel 718 at 100 m/min and 0.14 mm/tooth

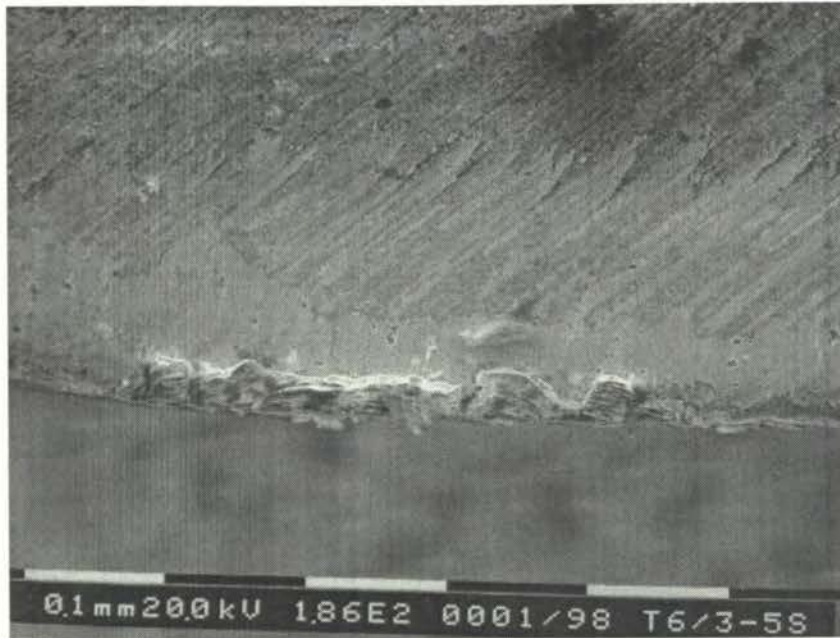
Figure 7. 8 (a) Delamination of the top coating layer at an initial stage of 5 seconds of cutting Inconel 718 with KC994M tool at 50 m/min and 0.14 mm/tooth. (b) EDAX analysis showing evidence of delamination of the top layer on the rake face of KC994M

In some cases, the original grinding marks on the substrates of PVD and CVD-coated tools were clearly visible indicating that the coating was peeled off rather than being worn as shown in SEM micrographs in Figures 7.9, 7.32 and 7.129a. The SEM images in Figures 7.8a, 7.11a and 7.98a suggest that in the case of cutting with CVD

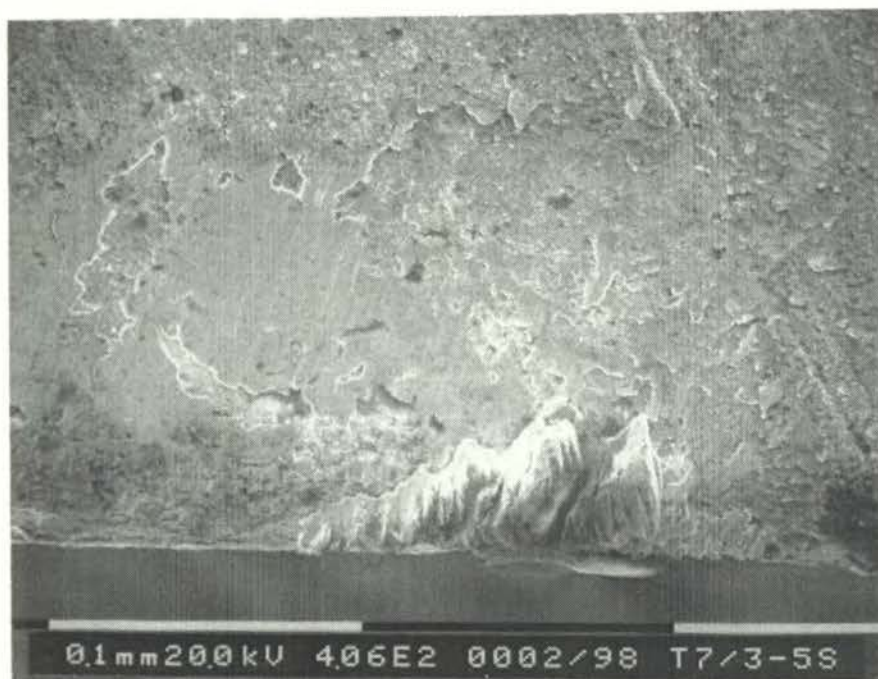
Figure 7. 10 (a) Workpiece galling and associated substrate plucking on the rake face of KC994M tool within first 5 seconds of machining Inconel 718 at 50 m/min and 0.08 mm/tooth. (b) Corresponding EDAX analysis showing evidence of substrate plucking and workpiece galling

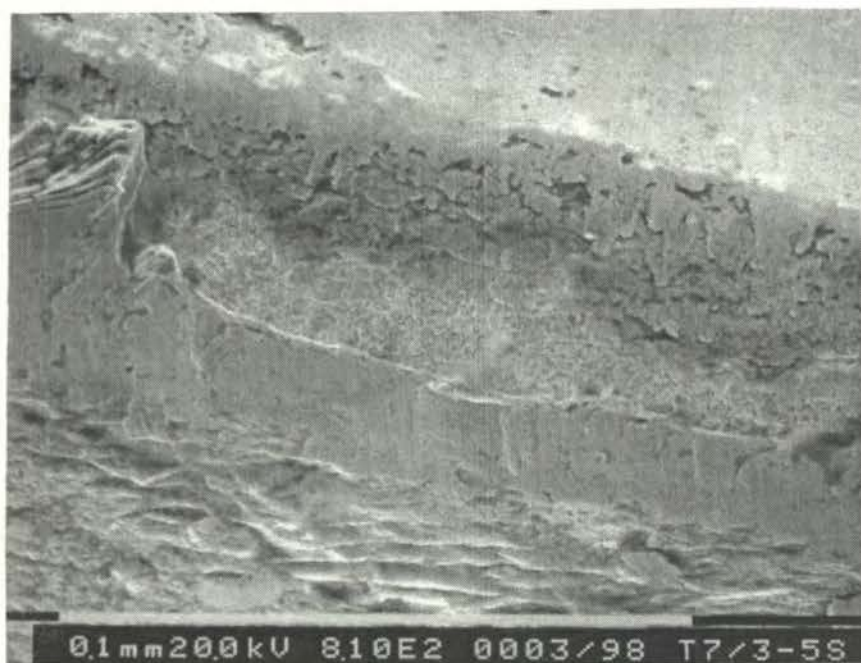
Figure 7. 11 (a) Collective presence of coating delamination (top layer of Al_2O_3), workpiece galling and adhesion, pitting on the rake face and microchipping at the cutting edge of KC994M tool occurring within the first 5 seconds of machining Inconel 718 at 75 m/min and 0.08 mm/tooth. (b) EDAX analysis showing evidence of the removal of the top coating layer

The second type of adhesion appears to be the welding of relatively bigger chip particles to the sharp section of the cutting edge and to the chipped or plucked areas, as shown in Figures 7.9, 7.11a, 7.26a, 7.45, 7.102a, 7.115, 7.144 and 8.2, when face milling both Inconel 718 and Waspaloy with CVD, PVD and uncoated tools. In general, this phenomenon became more pronounced at high cutting speeds of 75 and 100 m/min and feed rate of 0.14 mm/tooth. These Figures demonstrate that adhered workpiece material of this kind at the cutting edge had a structure that consists of several vertically stacked layers of workpiece material of unstable accumulation, resembling a kind of BUE. This structure indicates that the adhered material at the tool edge is most likely the end section of the chip which was left attached when the main body was broken away. This type of adhesion can also be very detrimental if it stays at the tip of the cutting edge, as it may act as a cutting edge hence adversely affecting initial transient contact configuration at entry and hence altering chip flow and shear pattern in the primary and secondary deformation zones. This in turn can cause micro chipping or substrate plucking at the time when adhered bulk of workpiece material is removed.

a) Adhered workpiece material, for instance, as in Figures 7.9, 7.11a and 7.102a, could act as a BUE, whereby the primary shear pattern and chip flow pattern would be altered. Adhered workpiece material in such a manner could also result in high localised stresses along the cutting edge when considering its irregular nature. This effect is believed to be more pronounced in the case of the PVD-coated tools which possess a sharper cutting edge than that of the CVD-coated KC994M and uncoated KMF tools (Figure 8.16).

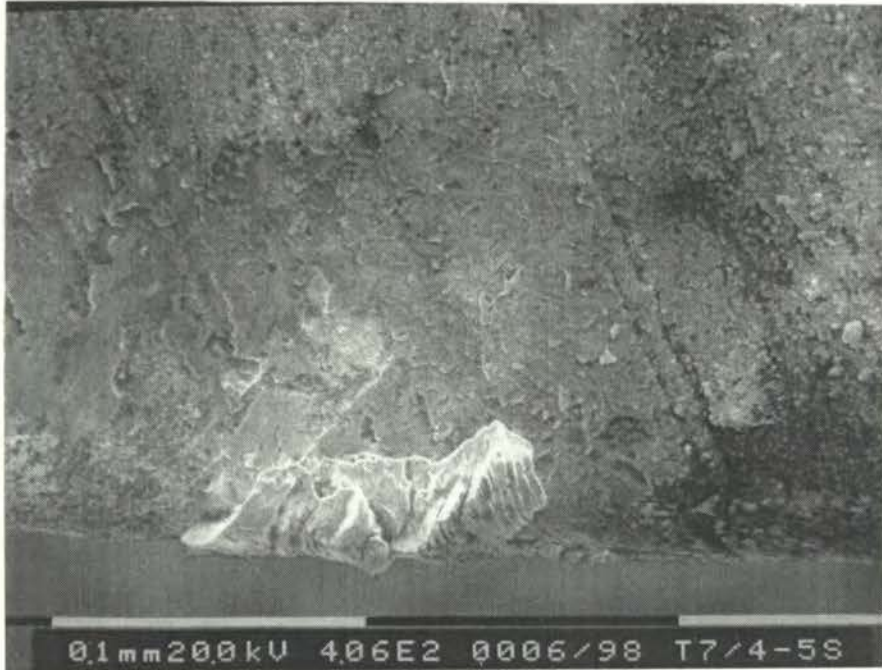
Figure 7. 13 Occurrence of coating delamination, workpiece adhesion and galling and associated substrate pitting at the highest cutting speed of 100 m/min and 0.08 mm/tooth, when machining Inconel 718 with KC994M tool, after cutting for 5 seconds.

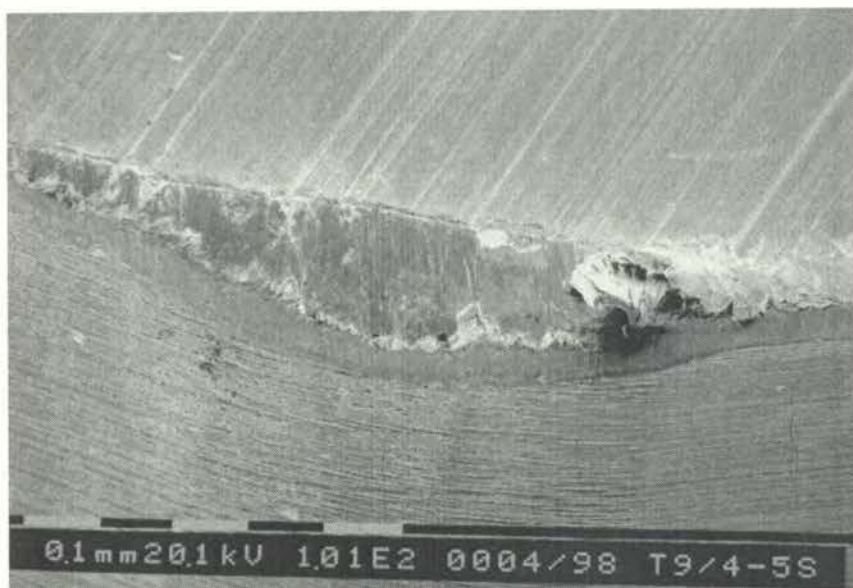
Figure 7. 16 Premature failure of KC720 tool by severe chipping/breakage and plastic deformation on the rake face after 20 seconds when machining Inconel 718 at 75 m/min and 0.14 mm/tooth

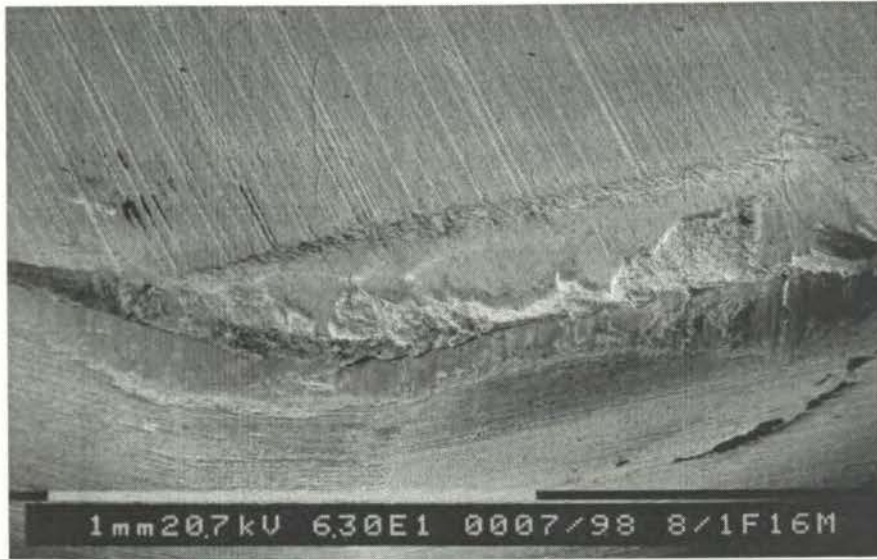
Figure 7. 17 Premature failure of KC720 tool after 5 seconds by severe breakage and workpiece adhesion when machining Inconel 718 at 100 m/min and 0.08 mm/tooth

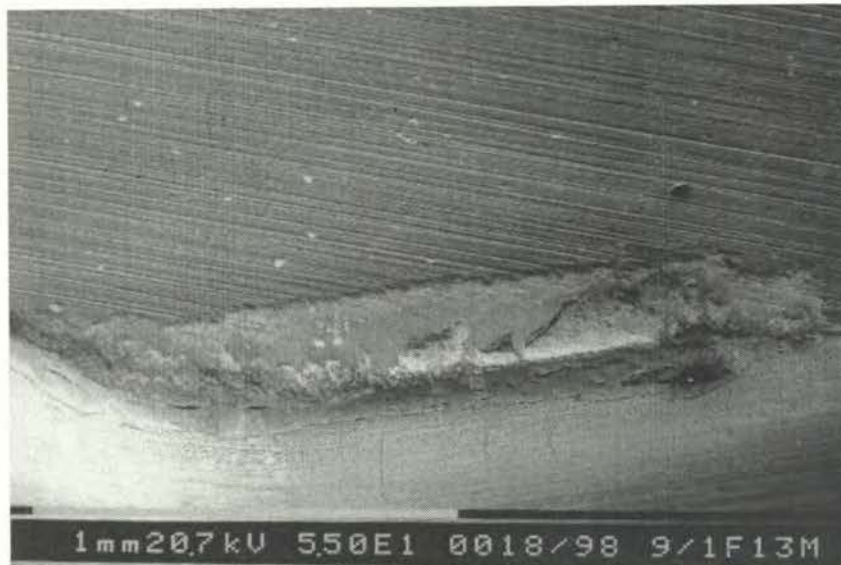
Figure 7. 18 Plucking, microchipping and workpiece adhesion on the failed KC720 tool cutting Inconel 718 for 16 minutes at 25 m/min and 0.14 mm/tooth

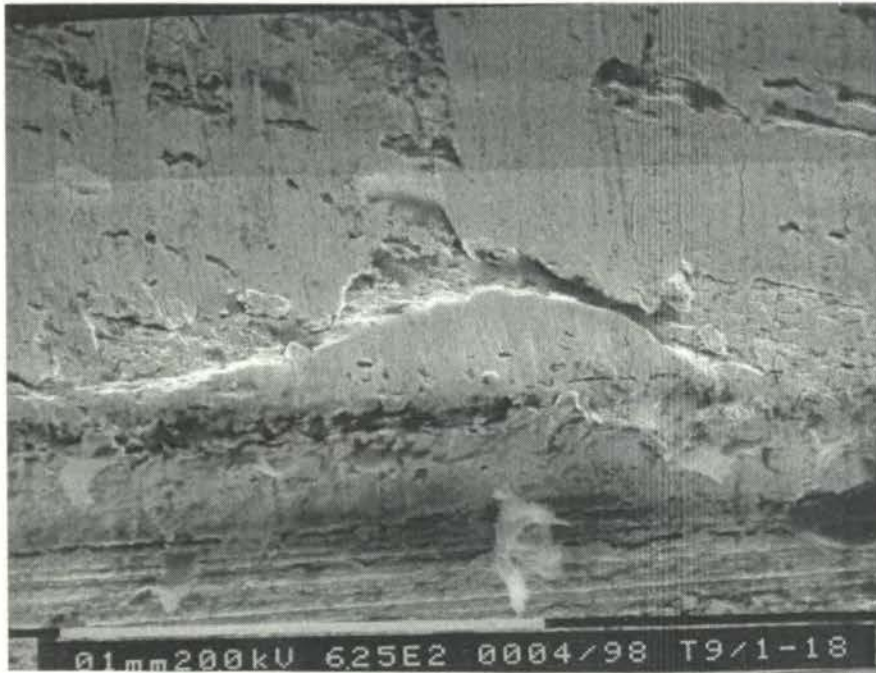
Figure 7. 24 A broad view of the cutting edge of KC720 tool showing dominance of workpiece galling on the rake and flank face galling after 18 seconds when cutting Inconel 718 at 25 m/min and 0.08 mm/tooth

7.21b, 7.25b and 7.26b were performed to confirm the presence of these failure and wear modes. The presence of microchipping and adhesion of chip particles was more pronounced at the initial cutting stage, when the cutting speed and feed rate were higher. Figure 7.24 shows a KC720 insert cutting for 18 seconds at the lowest speed of 25 m/min and feed rate of 0.08 mm/tooth with no visible microchipping and chip adhesion.

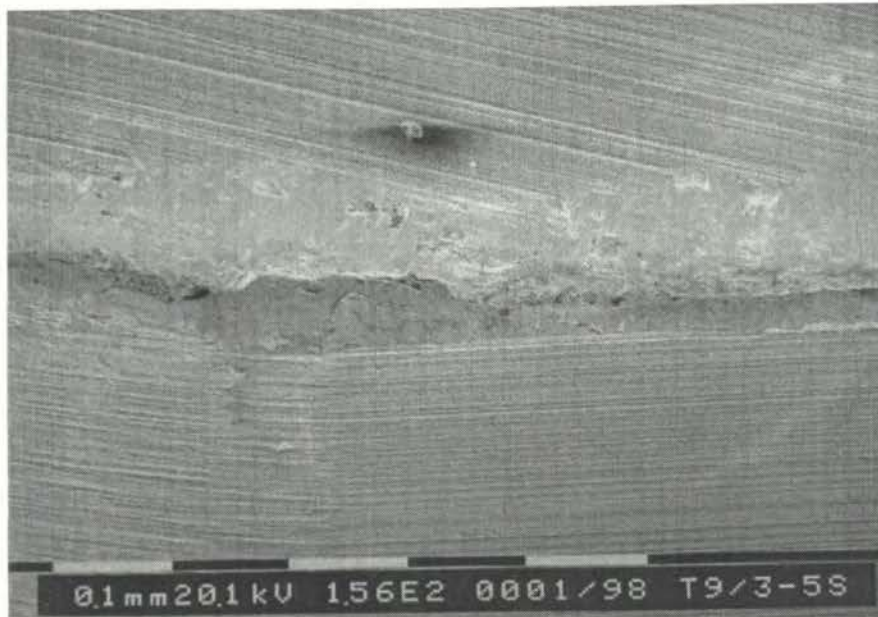
Figure 7. 25 (a) Magnified view of Figure 7.24 showing already pitted areas and initiation of plucking on the rake face. (b) EDAX analysis proving the substrate exposure on KC720 tool

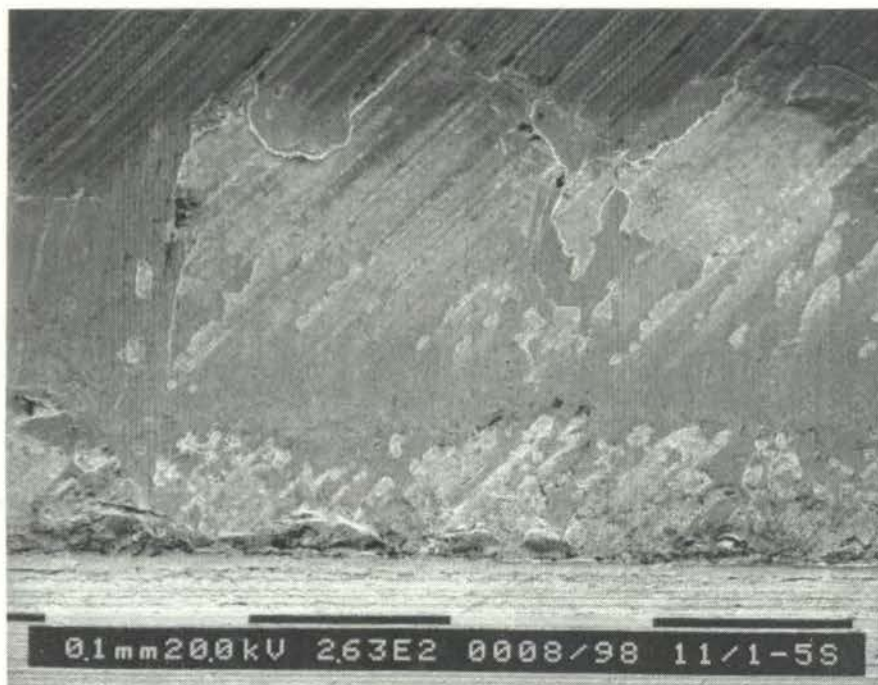
Figure 7. 31 General view of the entire cutting edge of KC730 tool after cutting Inconel 718 for 13 minutes at 25 m/min and 0.14 mm/tooth

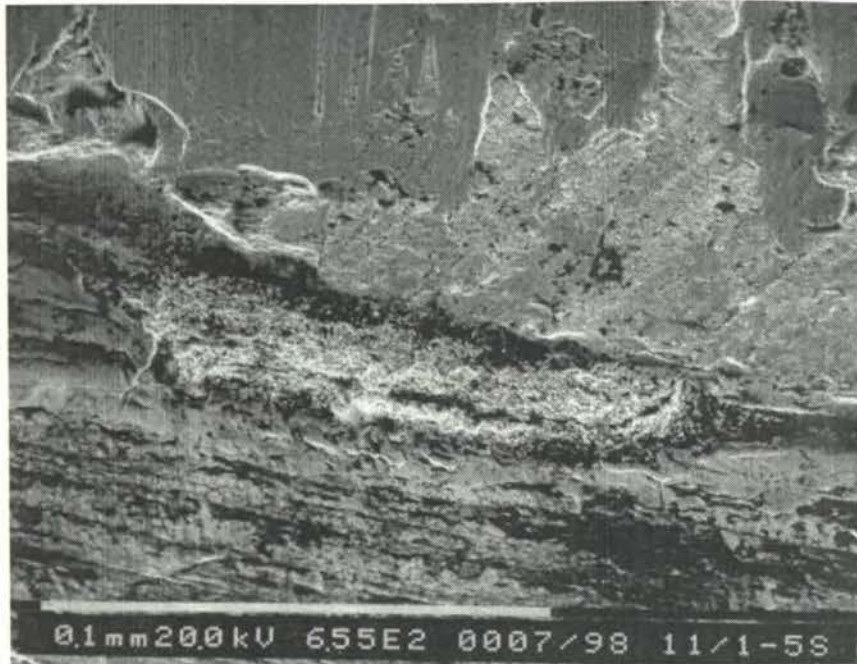
Figure 7. 32 Coating delamination and workpiece adhesion on the rake face of KC730 tool after cutting Inconel 718 for 5 seconds at 25 m/min and 0.08 mm/tooth

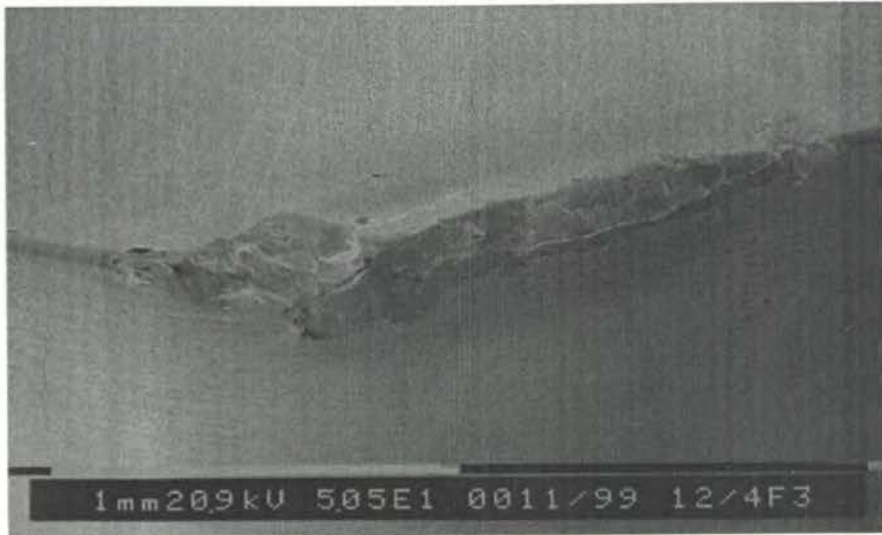
Figure 7. 39 A general view of KMF tool failed due to progressive chipping/plucking, workpiece adhesion and smooth flank wear after cutting Inconel 718 for 32 minutes at 25 m/min and 0.08 mm/tooth

KMF tools were rejected on reaching the average nose wear limit at low cutting speeds of 25 and 32 m/min for high and low feed rate conditions. At higher cutting speeds of 40 and 50 m/min, average flank wear was the dominant cause of tool rejection. Figures 7.38 and 7.39 show that tool failure at the lowest cutting speed of 25 m/min, was due to a combination of wear modes of workpiece galling, plucking and chipping. Figure 7.40 shows that at the cutting speed of 50 m/min, combination of severe chipping, breakage, workpiece adhesion and associated plastic deformation was the prominent wear mode responsible for tool failure.

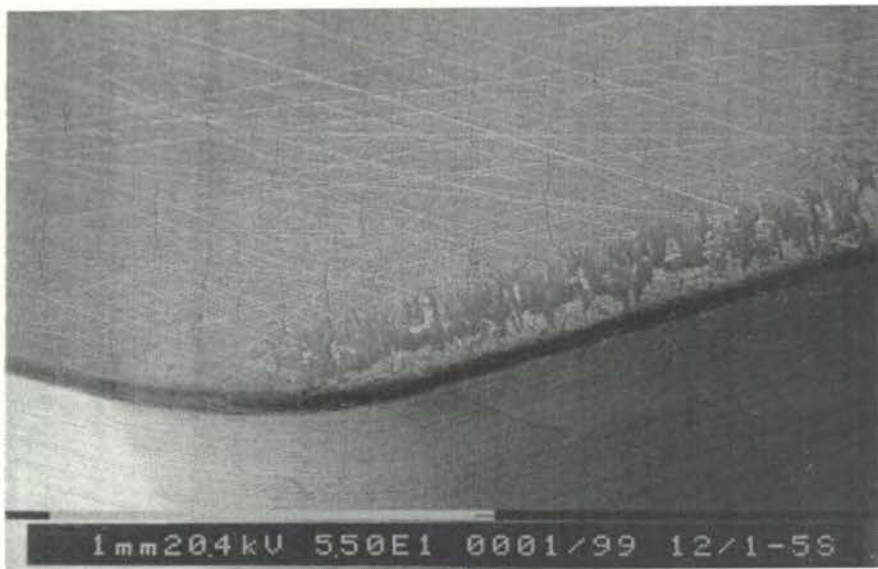
Figure 7. 40 Severe breakage along the entire cutting edge of a KMF tool after 3 minutes cutting of Inconel 718 at 50 m/min and 0.14 mm/tooth

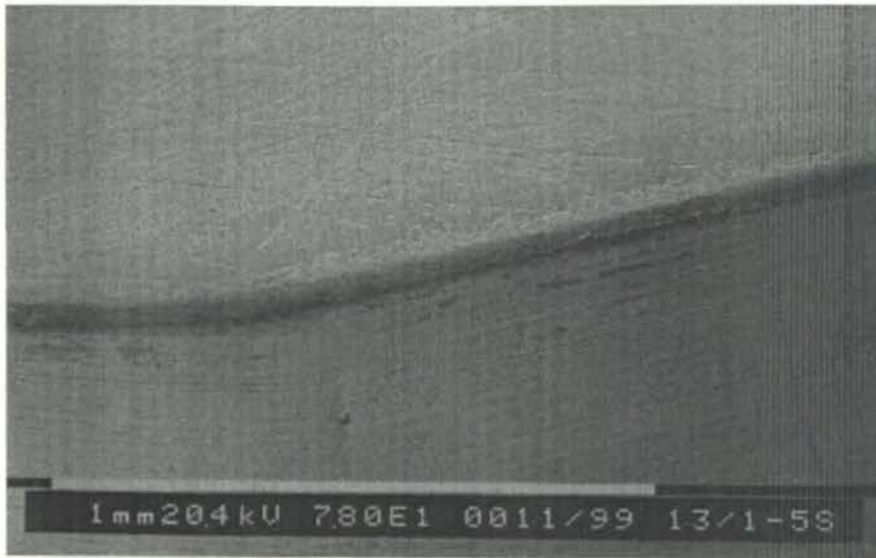
Figure 7. 43 Initial microchipping at the very cutting edge of KMF tool (same tool as in Figure 7.40 at a higher magnification)

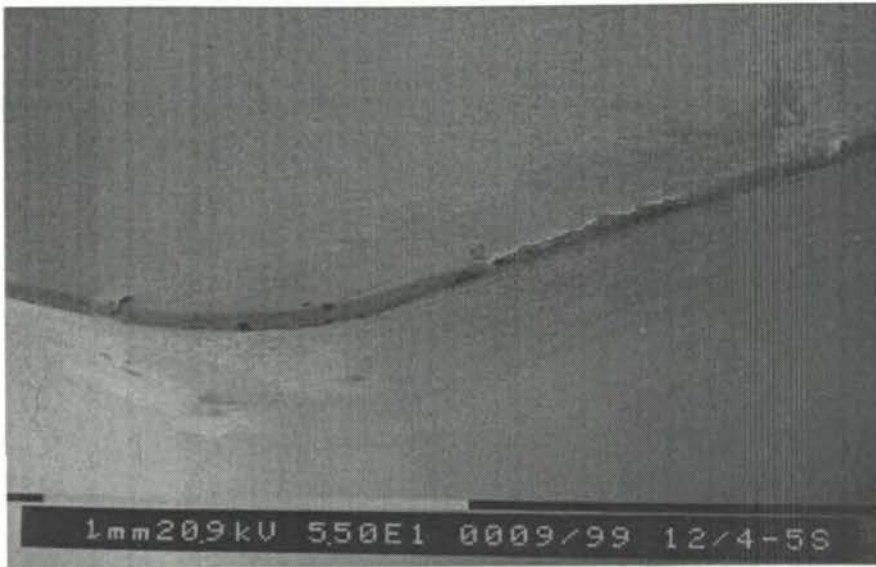
Figure 7. 45 Magnified view of the rake face of KMF tool in Figure 7.44, showing rake face pitting and adhered workpiece material

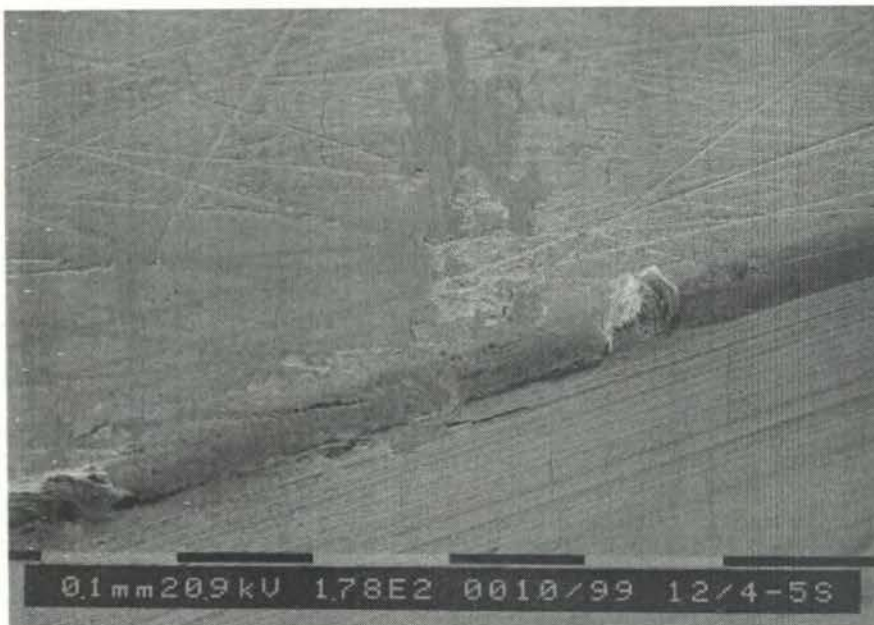
Figure 7. 46 General view of the entire cutting edge after cutting for 5 seconds, showing smeared and adhered large workpiece material when cutting Inconel 718 at 50 m/min and 0.14 mm/tooth

the cutting edge which are more prevalent at higher cutting speeds and most likely on the microchipped areas (Figure 7.46 and 7.47).

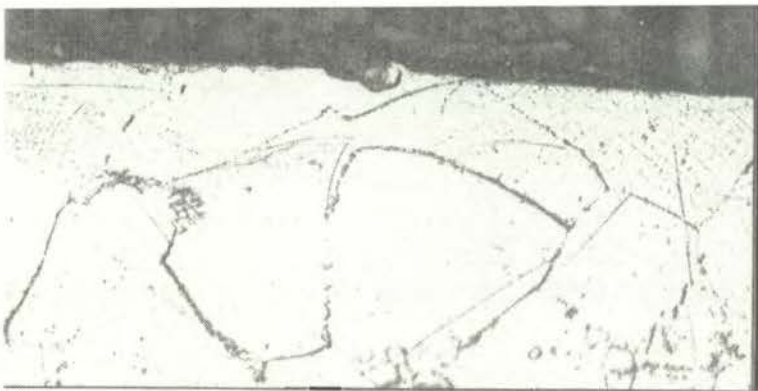
Figure 7. 67 Evidence of initial plastic flow after milling Inconel 718 with KC994M tool for 5 seconds at 25 m/min and 0.14 mm/tooth

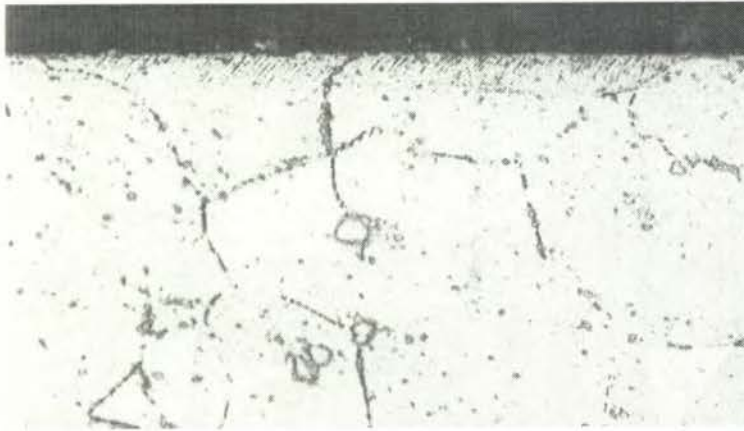
Figure 7. 69 Evidence of plastic flow and disturbed layer after milling Inconel 718 with KC994M tool for 54 minutes at 25 m/min and 0.08 mm/tooth

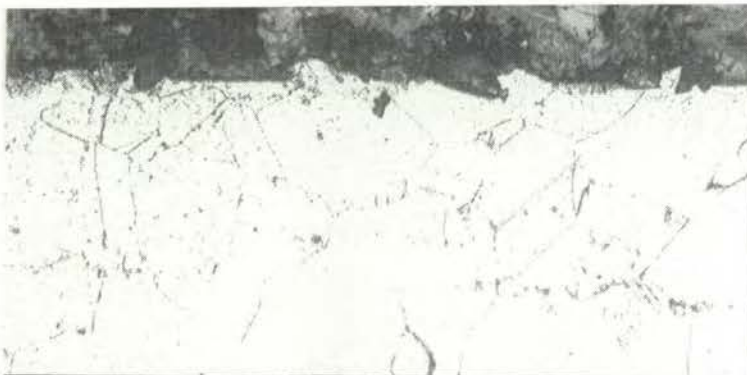
Figure 7. 70 Slight initial plastic flow after milling Inconel 718 with KC994M tool for 5 seconds at 25 m/min and 0.08 mm/tooth

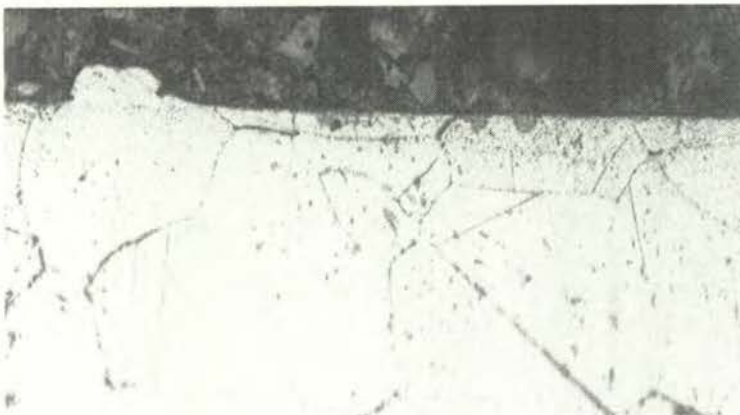
Figure 7. 73 Evidence of surface damage of initial cutting stage after milling Inconel 718 with KC720 tool for 5 seconds at 25 m/min and 0.14 mm/tooth (243X)

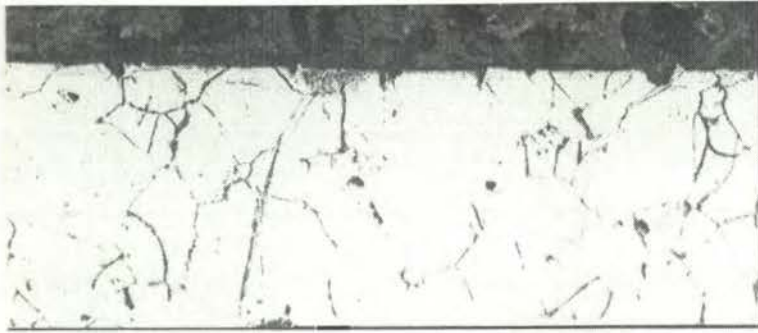
Figure 7. 74 Surface irregularity and slightly disturbed layer after face milling Inconel 718 with KC720 tool for 14 minutes at 25 m/min and 0.14 mm/tooth

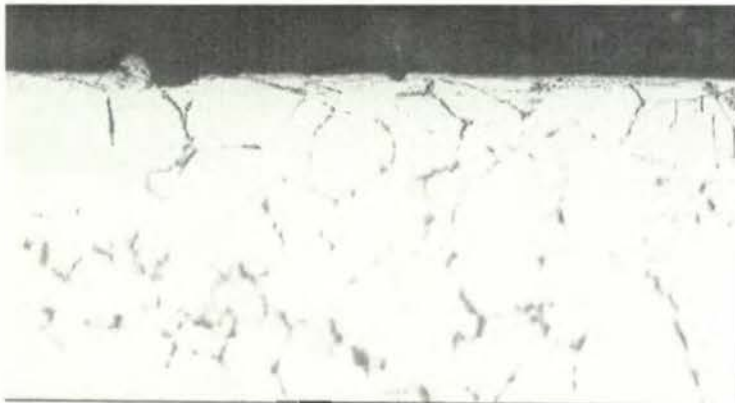
Figure 7. 78 Surface plastic flow after face milling Inconel 718 with KC730 tool for 14 minutes at 25 m/min and 0.14 mm/tooth

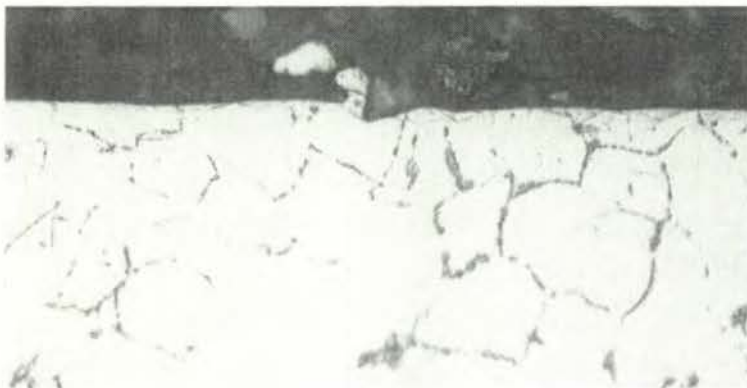
Figure 7. 79 Damaged and plastically disturbed surface layer after face milling Inconel 718 with KC730 tool for 14 minutes at 25 m/min and 0.14 mm/tooth

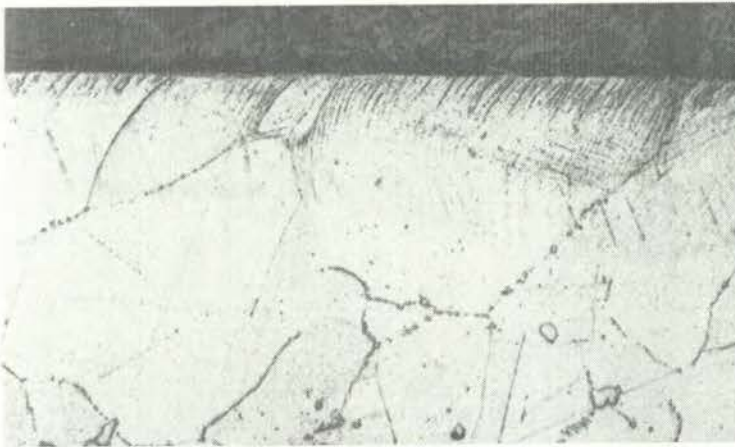
Figure 7. 85 Evidence of plastic flow after face milling Inconel 718 with KMF tool for 32 minutes at 25 m/min and 0.08 mm/tooth

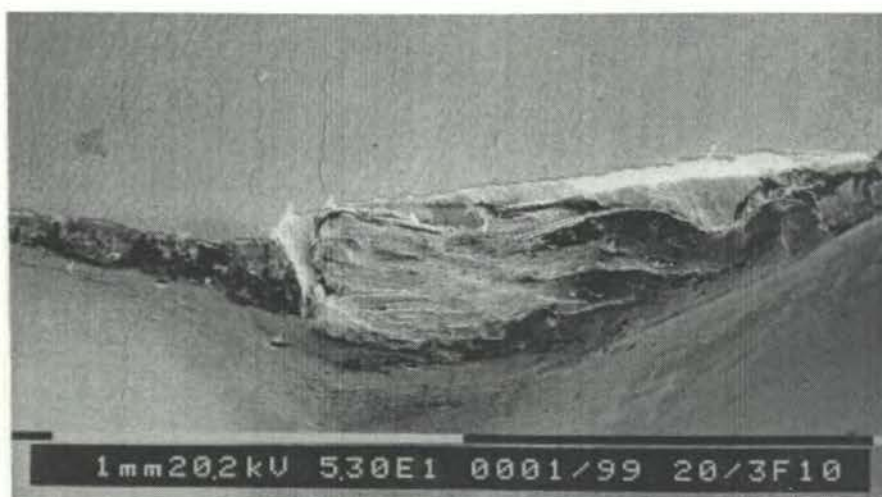
Figure 7. 89 The effect of cutting speed and feed rate when face milling Waspaloy with coated and uncoated tools

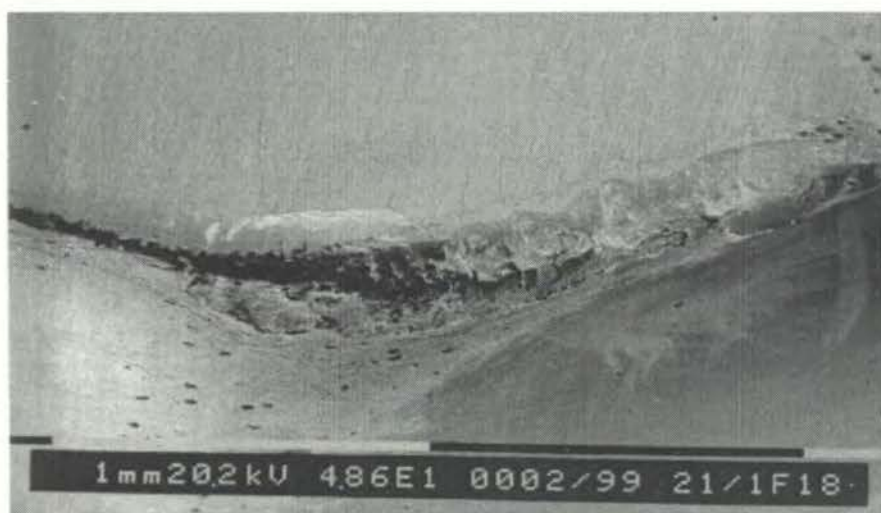
Figure 7. 90 Premature failure by severe breakage and chipping, and resultant workpiece adhesion and coating delamination on the plastically deformed rake of KC994M tool after 10 seconds cutting Waspaloy at 75 m/min and 0.14 mm/tooth

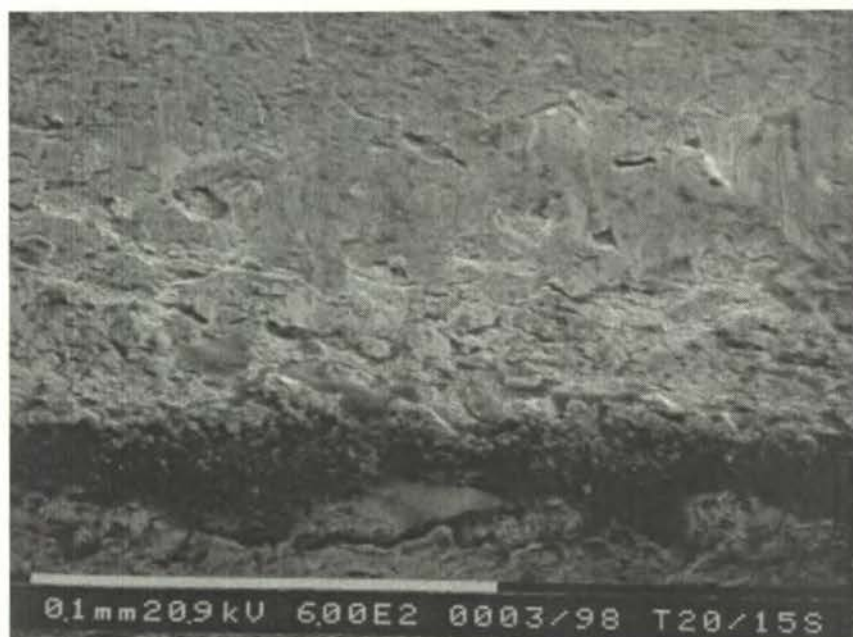
Figure 7. 98 (a) Premature delamination of Al_2O_3 top coating layer on the rake face of KC994M tool after machining Waspaloy for 5 seconds at 25 m/min and 0.14 mm/tooth. (b) EDAX analysis showing the exposure of second coating layer of TiCN on the rake face of KC994M tool

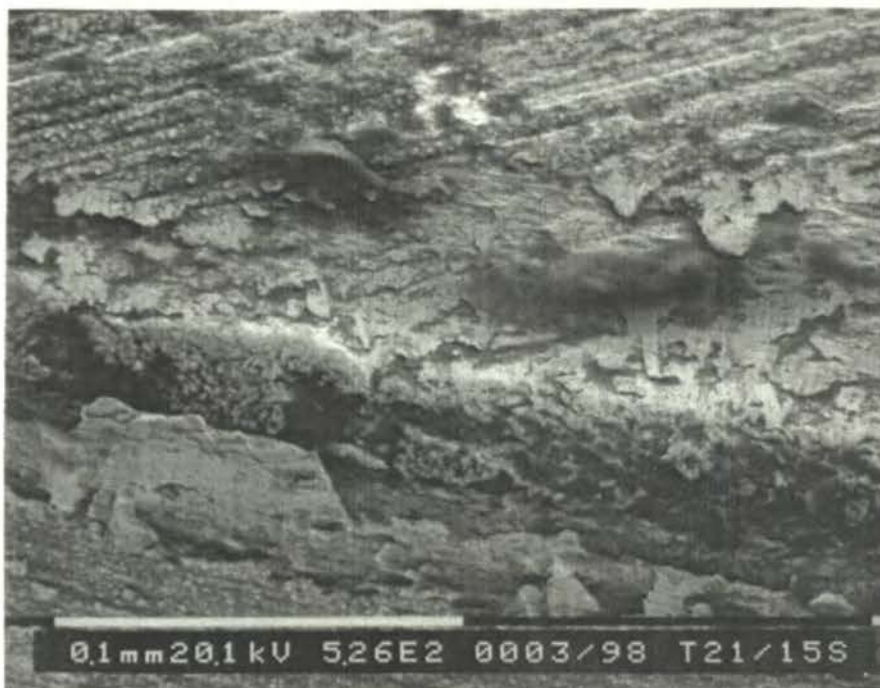
Figure 7.99 (a) Workpiece galling and substrate pitting at the cutting edge (rake face) of KC994M tool after machining Waspaloy for 5 seconds at 25 m/min and 0.14 mm/tooth. (b) EDAX analysis showing the exposure of tool substrate in the pitted areas

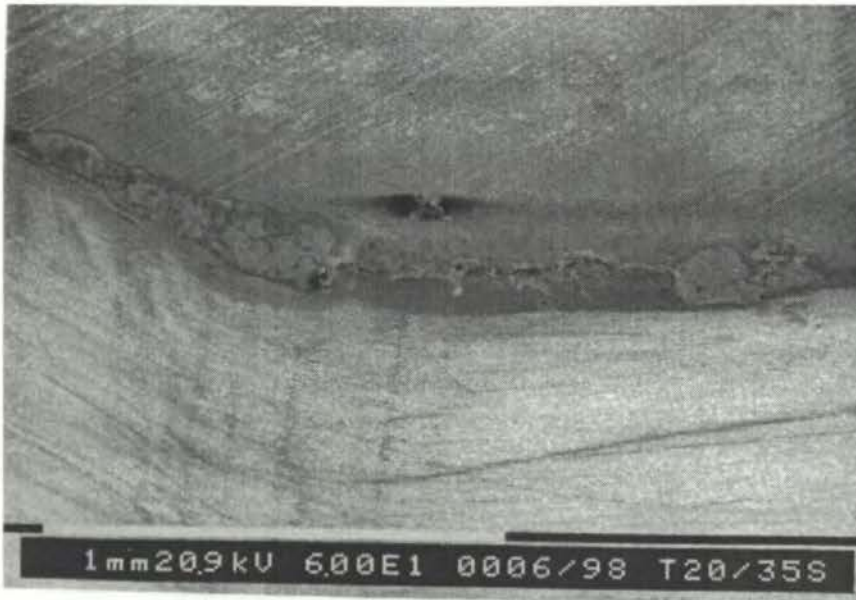
Figure 7. 100 (a) Workpiece galling and premature delamination of Al_2O_3 top coating layer on the nose rake and flank face of KC994M tool after machining Waspaloy for 5 seconds at 25 m/min and 0.08 mm/tooth. (b) EDAX analysis confirming the exposure of the second coating layer of TiCN on KC994M tool

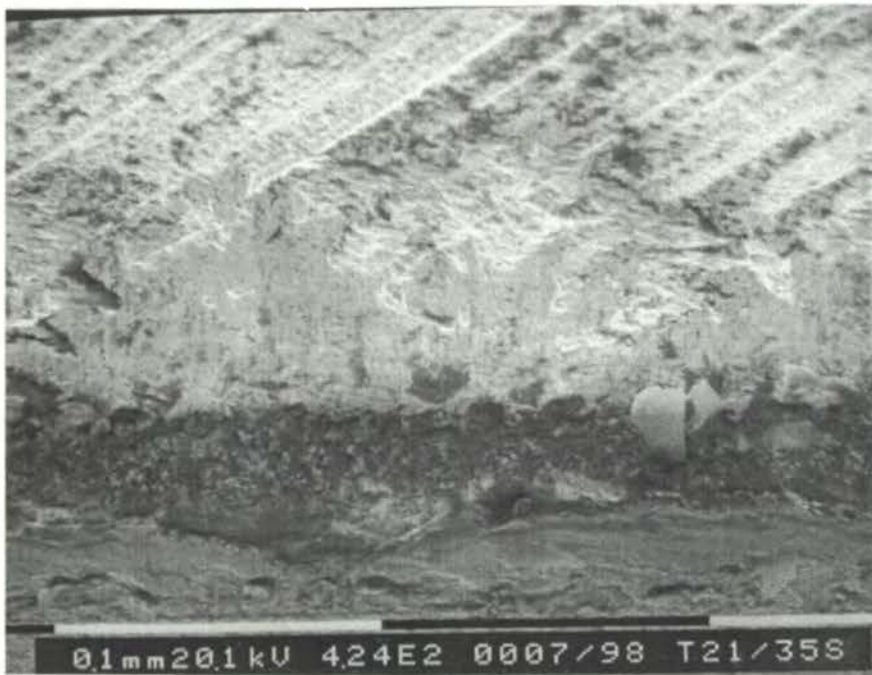
Figure 7. 102 (a) Excessive initial workpiece adhesion in the form of lumps and galling on KC994M tool after machining Waspaloy for 5 seconds at 75 m/min and 0.14 mm/tooth. (b) Respective EDAX analysis on KC994M tool indicating adhesion and substrate exposure

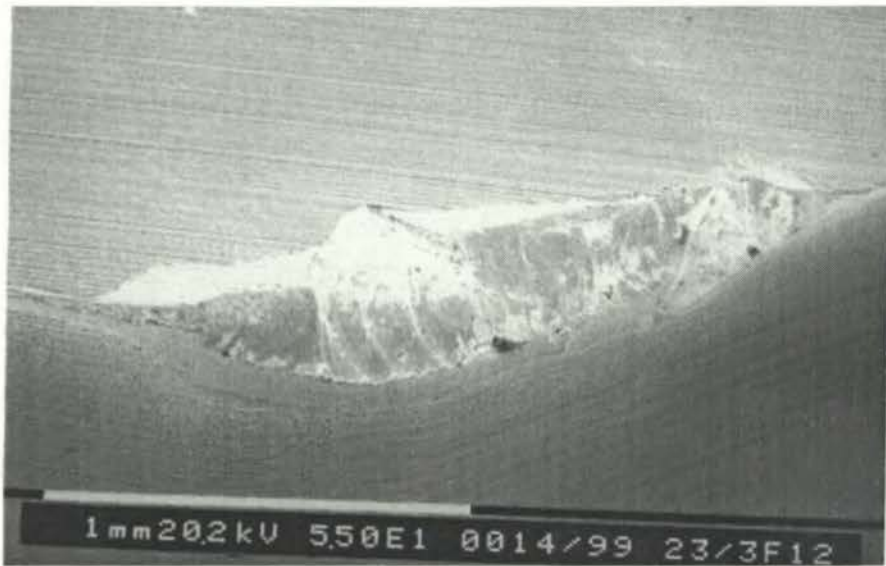
Figure 7. 105 Combination of chipping, plucking, coating delamination and galling on a failed KC720 tool after cutting Waspaloy for 5 minutes at 25 m/min and 0.08 mm/tooth

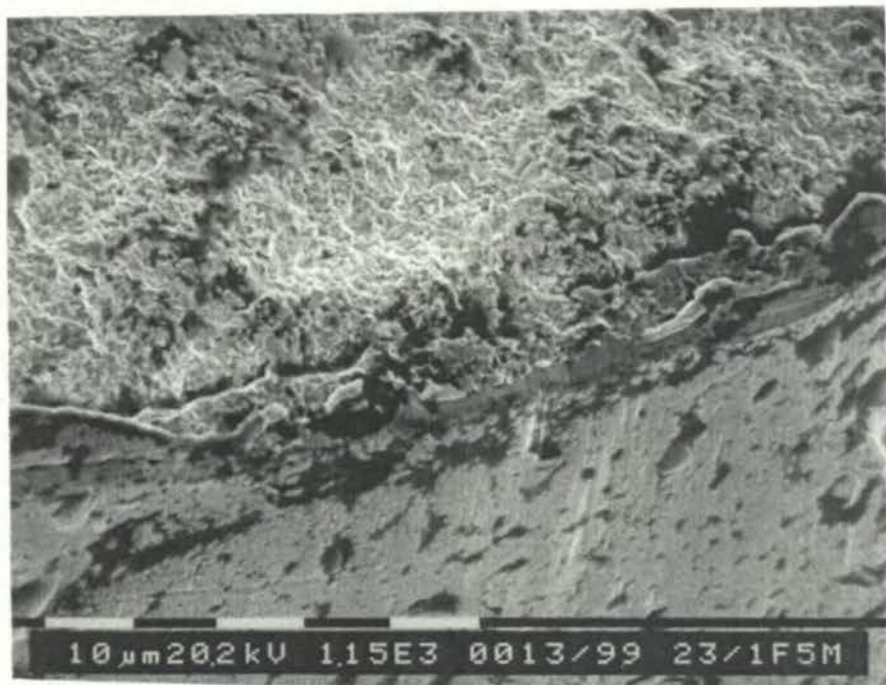
Figure 7. 107 Crack running parallel to the cutting edge of a failed KC720 tool with smooth flank wear after cutting Waspaloy for 5 minutes at 25 m/min and 0.08 mm/tooth

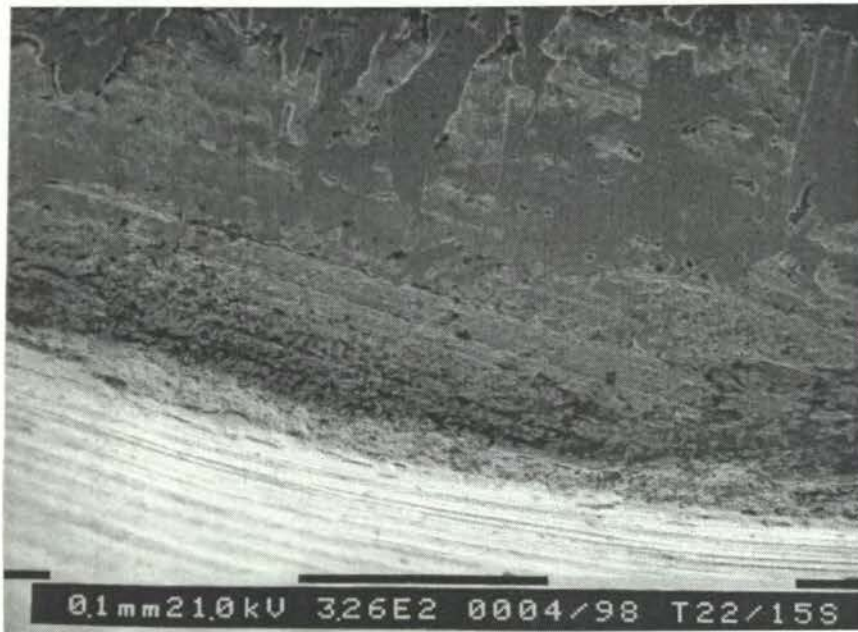
Figure 7. 116 (a) Initial microchipping, coating delamination and galling on rake face of a KC720 tool after cutting Waspaloy for 5 seconds at 25 m/min and 0.14 mm/tooth. (b) EDAX analysis proving premature substrate exposure on KC720 tool

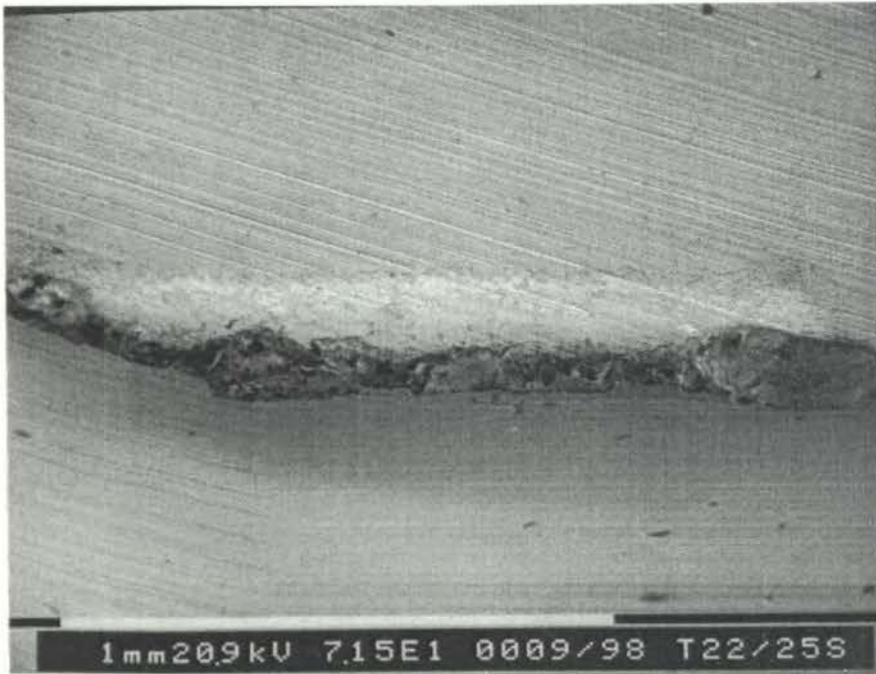
Figure 7. 118 Severe premature chipping on a KC720 tool after cutting Waspaloy for 5 seconds at 50 m/min and 0.14 mm/tooth

Examination of the cutting tools, at an early stage of cutting for 5 seconds, reveals important information on the wear behaviour of coating and cutting edge. SEM micrographs in Figures 7.113 to 7.118 show that workpiece galling, coating delamination and substrate pitting occurred at all cutting speeds and feed rates used. At the cutting speeds of 50 to 100 m/min, severe chipping was observed in addition to galling and coating delamination, as shown in Figure 7.118. EDAX analysis, presented in Figures 7.116b and 7.117b, confirm the presence of galling, coating delamination and microchipping.

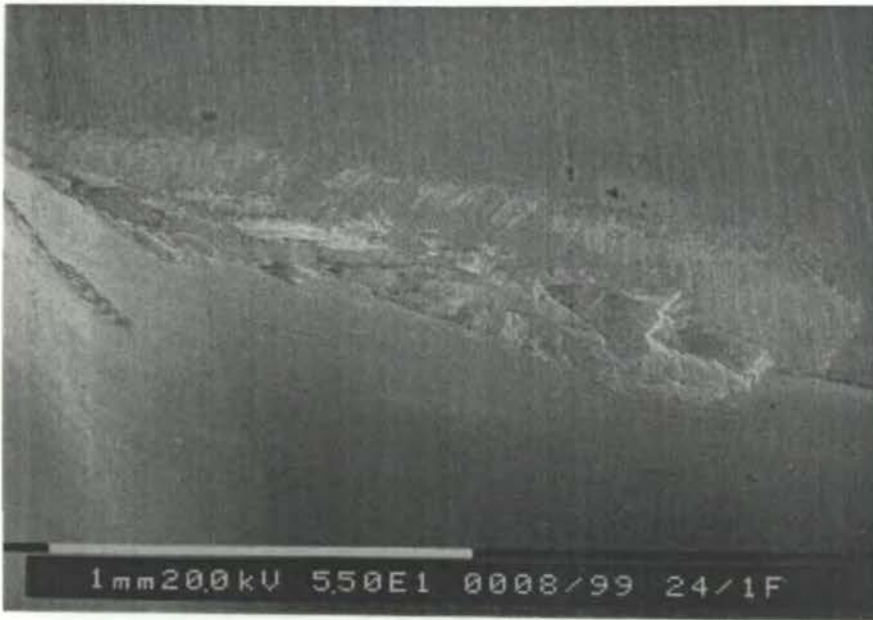
Figure 7. 120 Severe chipping, plucking, coating delamination and workpiece adhesion on a failed KC730 tool after cutting Waspaloy for 110 seconds at 25 m/min and 0.14 mm/tooth

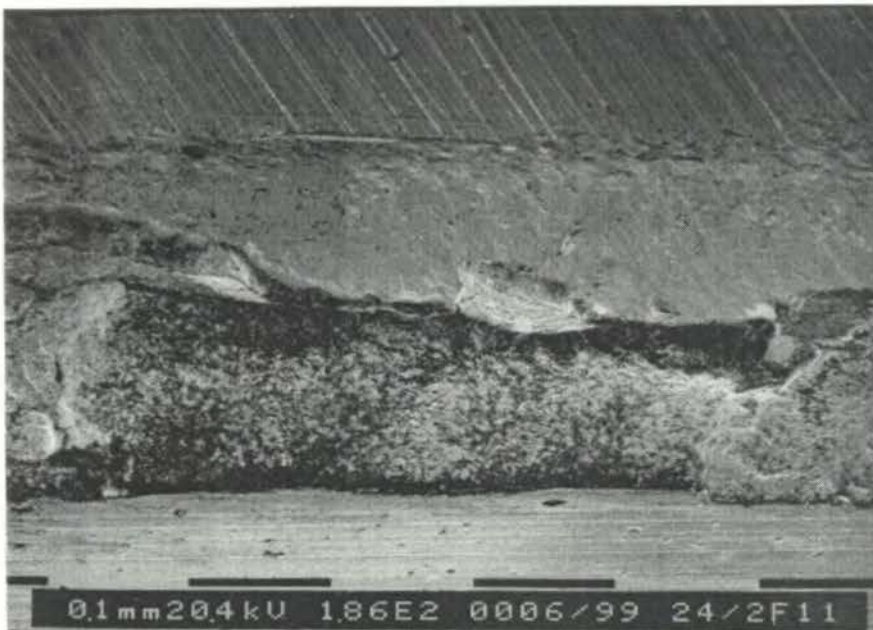
Figure 7. 121 Severe premature breakage of the cutting edge of a failed KC730 tool after cutting Waspaloy for 11 seconds at 50 m/min and 0.14 mm/tooth
